**Energy Performance**

#### Two Year Report Card on the 'Khanh Master–Slave' Variant of the BIS \$1K Solar Water Heater

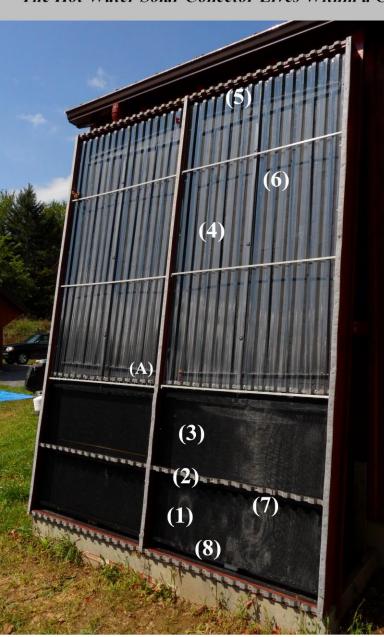
#### The Hot Water Solar Collector Lives Within a Gardener's 'Cold Frame'

- (1) Air near front is warmed by double wire screen.
- (2) Air rises at back along face of black painted aluminum.
- (3) Air rises up through screens again towards front glazing.
- (4) Warmed air rises up between the inner and outer glazing, reducing conductive thermal losses from the front of the hydronic collector.
- (5) Hot air passes back to rear of collector assembly.
- (6) Air conveyed within insulated plennum, and slowly falls down the back side of the collector. Very little conductive loss at back side due to warm air bath.
- (7) Air continues down rear of slave collector, preventing heat loss over the rear side.
- (8) Air is drawn forward into bottom of slave air heater to recycle.

Note A: Lowest permissible height for gravity drain-back.

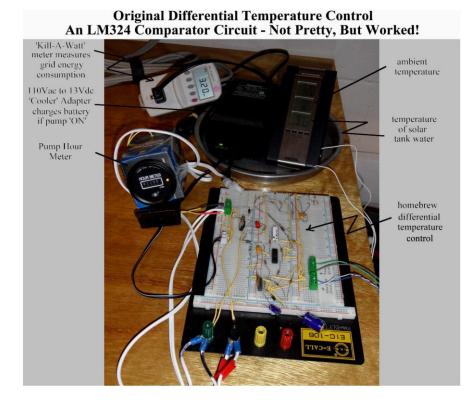
#### Differential Temperature Controller:

The 'comparator' control had no major issues, but it lacked the ability of accurate temperature adjustment.

## The Fix: It has now been replaced by a homemade digital controller based upon a Comfile Cubloc CB210 - an article covering the new controller is coming soon on Build-It-Solar.

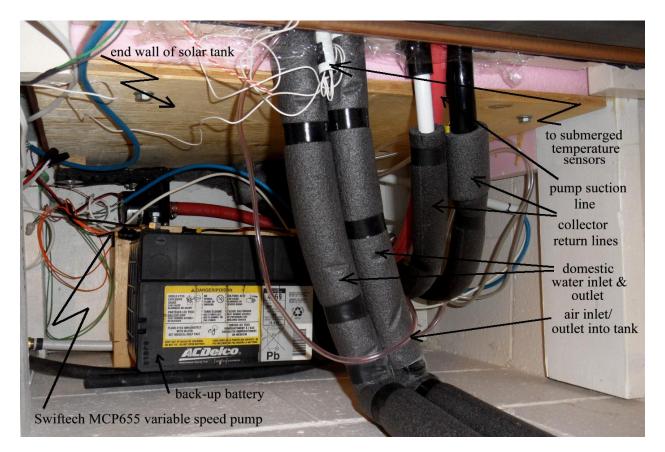
The original Swiftech pump ran about 1290 hours per year, and consumed only about 50 kWh net per year. It seemed to have worked flawlessly – but the introduction of a Koolance flow meter (Feb. 2013) suggested that the flow rate had degraded significantly (either that or the flow meter was inaccurate, or the degradation was due to the flow meter?). As the outside of the copper heat exchanger was no longer shiny bare copper, perhaps there had been an increase in pipe friction on the inside of the PEX and copper tubing. There had been an issue with mold identified in June 2012. Could it have contributed to the pipe friction/flow issue?

The (Attempted) Fix: In Feb. 2013 a small amount of bleach was added to the system (~25ml) for the first time, but whether there has been a flow improvement is not yet evident.

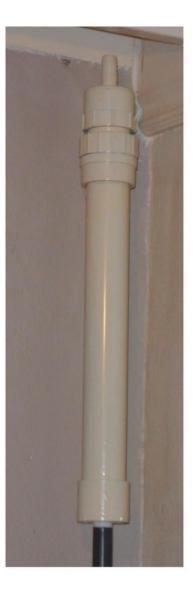
In view of the reduced flow rate, and the introduction of the new digital differential controller, it was feasible to install a second pump to significantly improve flow rate. In the original construction article (see Introduction for web link), there is reference to the initial difficulty of initiating gravity drain-down at pump shut-off. The fix at the time was to introduce a 'vacuum breaker'. It was simply a thin vinyl tube running up to the ceiling, connected to the two collector return lines as they entered inside the house. Two valves were provided at this junction and cracked open just enough that air would enter the return lines to assist the starting of gravity drain-down. This worked well as the pump never had enough pressure to lift the water level near the ceiling. Not so with the addition of a second pump! If the controller engaged both pumps at start-up, occasionally a burp of several ounces would spill out the air vent – and into the boss's wool cupboard!

A new float actuated valve has been added to the top of the vacuum breaker tube to prevent collector return water from occasionally spilling into the house under the extra pressure of the second pump.

It was constructed from 1 1/4" black ABS drain fittings (top & bottom) and an inline, sump pump valve (positioned upside down near the top).

Inside, a float closes the valve. Float is simply a 12" length of 1" PVC with end caps.

The Fix: A float valve was constructed that would close tightly when the water level rose to within two feet of the ceiling, and otherwise remain open as an air inlet. A 1 1/4" ABS inline valve (commonly used with sump pumps) was configured up-side down so that the rubber valve hung downward. A simple float was made from a foot of 1" PVC (capped both ends), and positioned within an ABS drain pipe and connected to the top of the vinyl vent tube. The float valve works flawlessly, and saves a lot of grief.

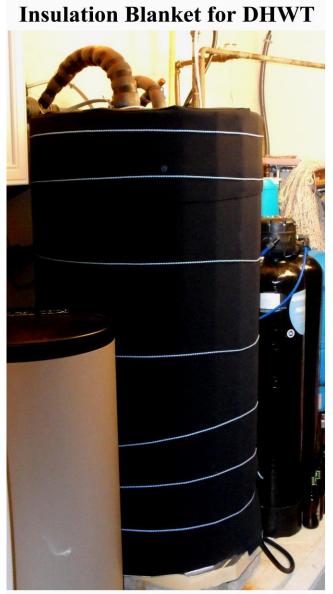
*Over the two year period, the conventional electric hot water heater (DHWT) was the least reliable aspect of the entire solar water system.* One element had previously failed, a second failed and was replaced. The other element developed a leak, corroding the tank at the seal.

Both the new and old tank had about an inch of foam insulation and the claimed standby thermal losses were said to be about 90 watts 24/7 (perhaps at 140 deg. F. and ideal conditions?). With a new tank, it seemed appropriate to

2 inch foil faced foam cut in strips, taped together with 'Red' construction tape, and covered with neoprene 'wet suit' material.

$2^{nd}$  Fix: Using a table saw, strips of 2 inch thick, foil faced urethane insulation were cut in a trapezoidal shape (3 3/4" on the outside, 3 1/4" on the inside), and taped with 'red' construction tape into a blanket. A circular top and bottom were also made from the 2" urethane. The entire blanketed tank was then wrapped in surplus neoprene foam fabric (wet suit material) and laced up to be easily removable for tank servicing. The net result is a tripling of the insulation, and hopefully a two thirds reduction in tank heat loss.

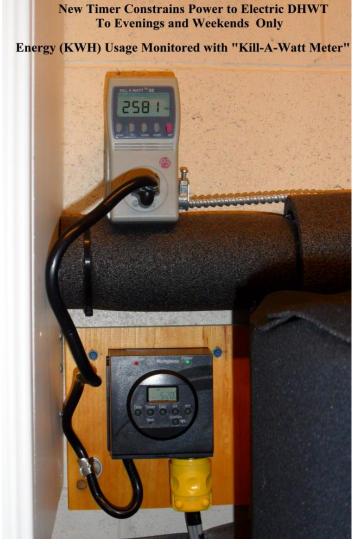
Electricity is very expensive in Ontario. With 'smart' meters and variable rate pricing, off-peak (night-time & weekend) pricing is half of the peak rate. Restricting electrical consumption to off-peak times - especially water heater electrical usage, is important! Two years ago, 230 volt ac electrical timers with accurate clock mechanisms were difficult to source. The home-brew fix was to acquire a programmable furnace thermostat, and use it as a clock to trigger an optically isolated, zero crossing solid state switch. Construction involved a back-up power

supply and boxes, fittings and a fair amount of work – at a cost of about \$125. Running the DHWT at 115 volts (rather than 230Vac) enabled the documenting of energy consumption using a common 'Kill-A-Watt' meter. Powering a resistive load at half voltage reduces the consumption rate (and heating capability) to one quarter power – and is far gentler on the heating elements.

The Fix: As of Feb. 2013, heavy duty, accurate electronic timers have become available here at very reasonable cost – but they too, are 115 volt. The home-brew furnace thermostat/timer has now been replaced by a heavy duty UL listed 'Intermatic' programmable timer – total cost now \$7 !!
